# **EVALUATION OF MILITARY FUELS USING A FORD 6.7L POWERSTROKE DIESEL ENGINE**

## **INTERIM REPORT TFLRF No. 415**

**Contract No. W56HZV-09-C-0100 (WD0004 & WD0008)**

**August 2011**

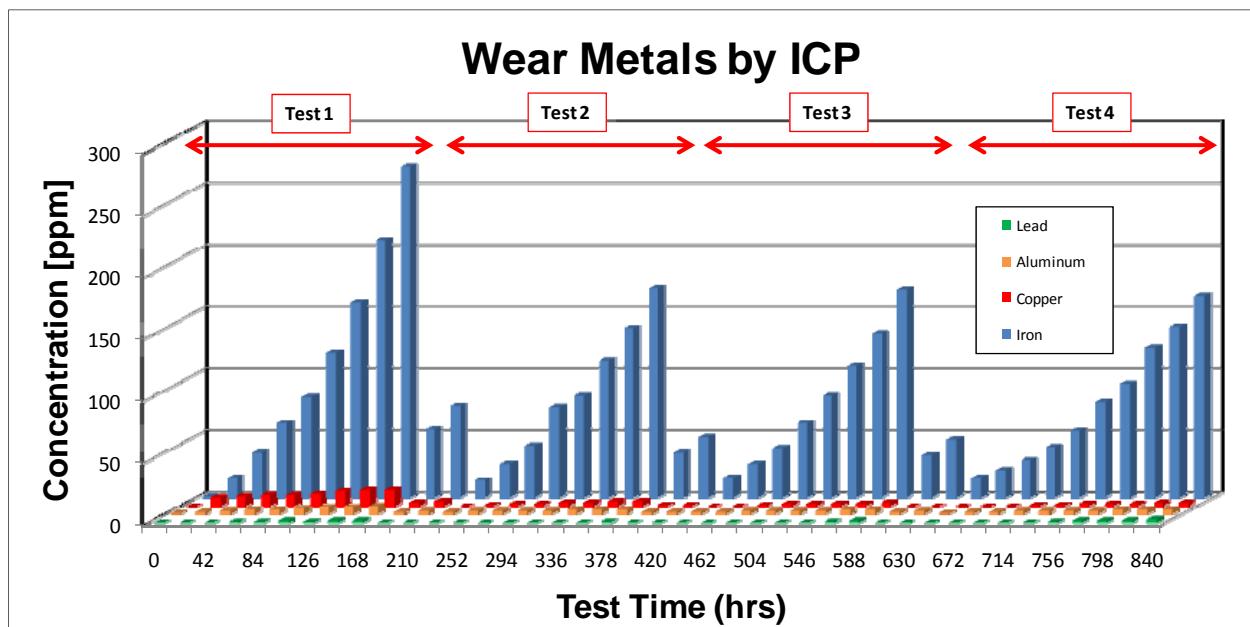
**Figure 7 - Accumulated Wear Metals Over 840hr Engine Testing Duration**

Used oil samples were sampled daily for analysis to determine oil change intervals and to provide an indicator of engine condition that could be easily compared across all four tests. No unusual wear metal accumulations were noted during any of the tests. Iron (Fe) accumulation rates changed from the first test to the following three, consistent with what would be expected during engine break-in. No other significant accumulations of typical wear metals were noted. Figure 7 shows four typical engine wear metal accumulations over the life of the engine and test program. This supports that no adverse engine degradation was experienced that could potentially bias test results.

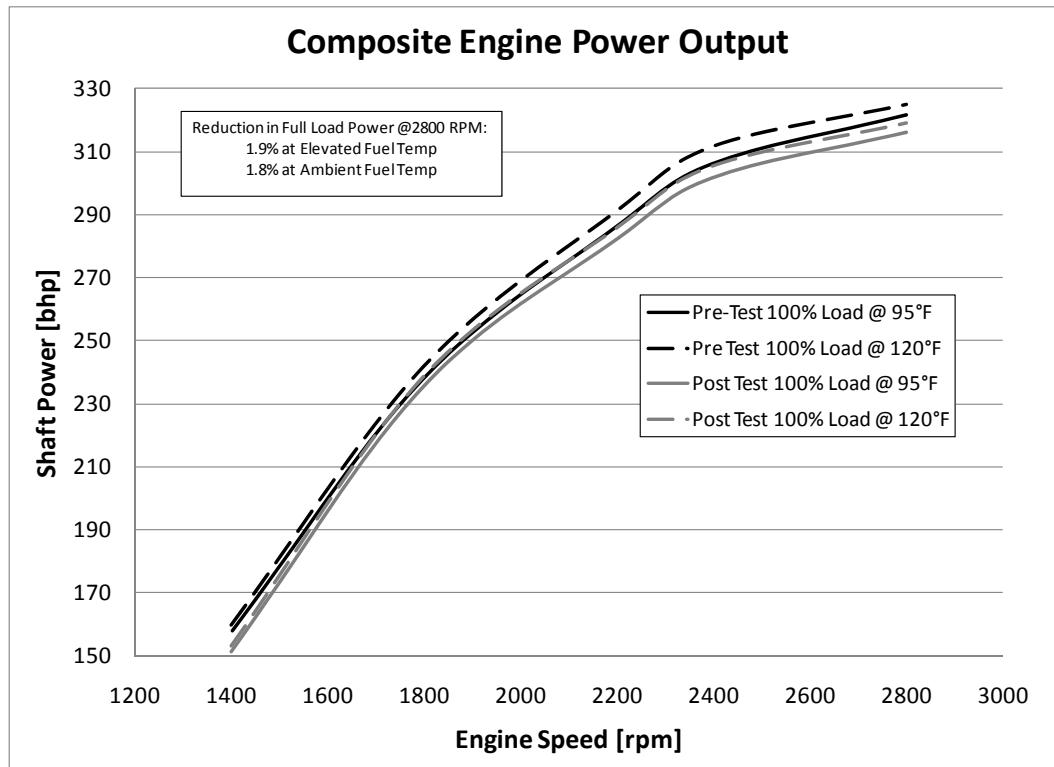
**Figure 8 - Ford 6.7L, ULSD, Pre & Post-Test Full Load Powercurve**

Unfortunately, during the ULSD, JP-8, and 50/50 test, the 6.7L engine experienced a steady decrease in engine boost pressure resulting in a loss of engine power output across each test duration. This was noted in the pre and post-test powercurves for each of the first three tests. During investigation into these trends, no other causes were identified for the documented power loss. Engine power spot checks were completed using ULSD at the completion of testing on both post-test hardware and newly installed hardware to determine if the fuel system components had experienced wear during testing resulting in the engines performance change or variation. These spot checks did not yield any significant change in engine output between the used and new fuel system hardware, thus ruling out fuel system degradation as a possible cause. At the completion of the 50/50 test, engine output had decreased to more than 5% below new engine output, and it was determined that a replacement turbocharger assembly be installed to avoid any further engine boost degradation or PCM commanded engine de-rates due to insufficient boost pressure. After installation of the replacement turbocharger assembly, the engine power output returned within approximately 1% of new engine output and testing continued. Despite this steady loss in power over the first three tests, engine fuel consumption rates remained consistent across each test, thus not invalidating the overall test goals. As a consequence of the consistent fueling coupled with the reduction in mass air flow through the engine, the measured Air Fuel Ratio (AFR) gradually enriched throughout the effected tests and could be seen as an increase in exhaust port temperatures throughout each of the first three tests. As expected, the AFR of the final test was corrected with the replacement turbocharger assembly, and exhaust port temperatures returned back to expected values, further supporting the turbocharger as culprit of the engine power degradation.

Figure 8 below shows the pre and post-test full load powercurve testing for ULSD. The engine experienced a respective 1.8% and 1.9% power loss over the test duration at ambient and elevated fuel inlet temperatures.

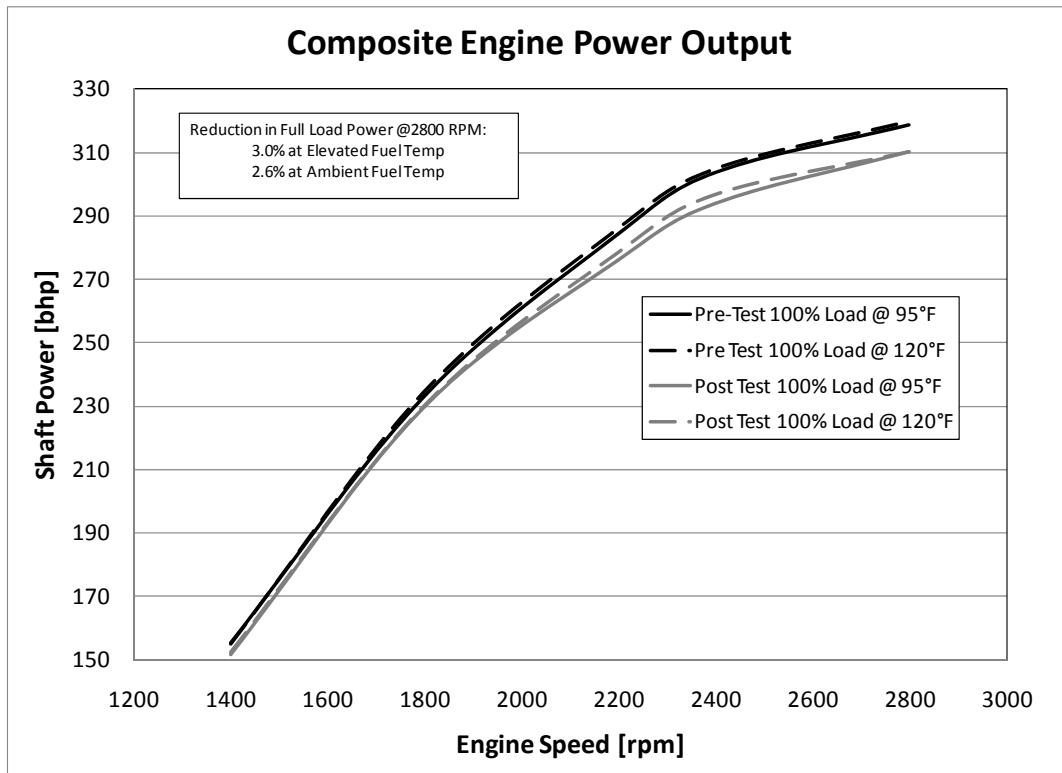
**Figure 9 - Ford 6.7L, JP-8, Pre & Post-Test Full Load Powercurve**

Figure 9 below shows the pre and post-test full load powercurve testing for JP-8. The engine experienced a respective 2.8% and 3.0% power loss over the test duration at ambient and elevated fuel inlet temperatures.

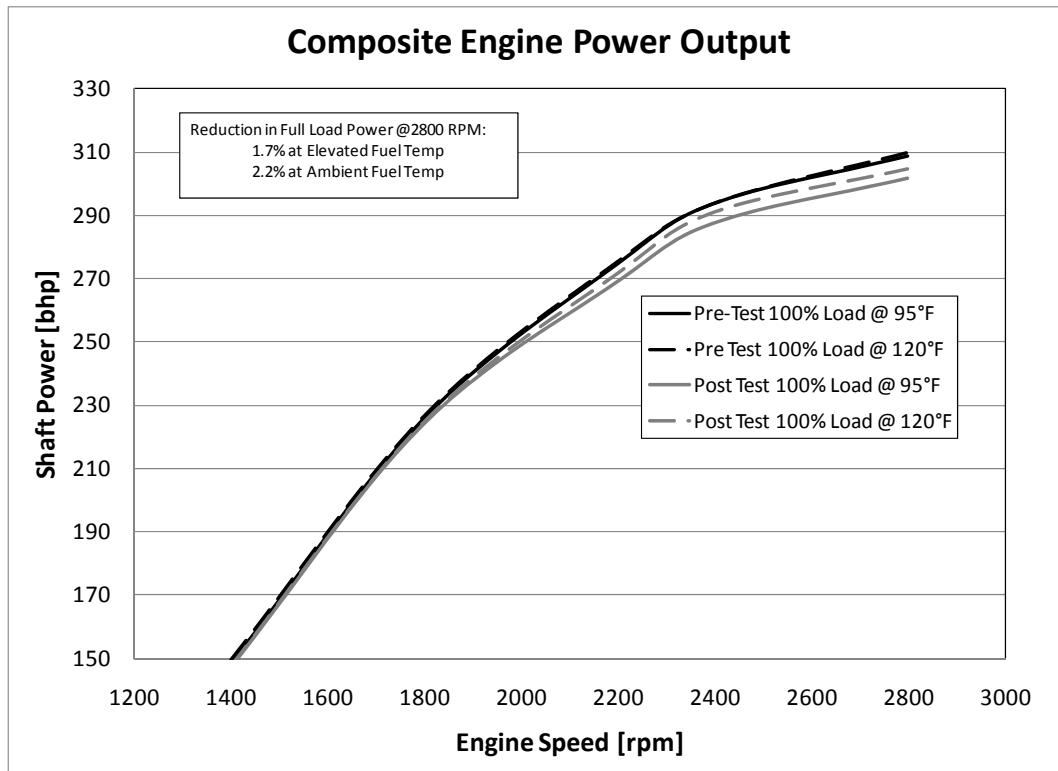
**Figure 10 - Ford 6.7L, 50/50 JP-8/SPK, Pre & Post-Test Full Load Powercurve**

Figure 10 below shows the pre and post-test full load powercurve testing for 50/50 JP-8/SPK. The engine experienced a respective 2.2% and 1.7% power loss over the test duration at ambient and elevated fuel inlet temperatures.

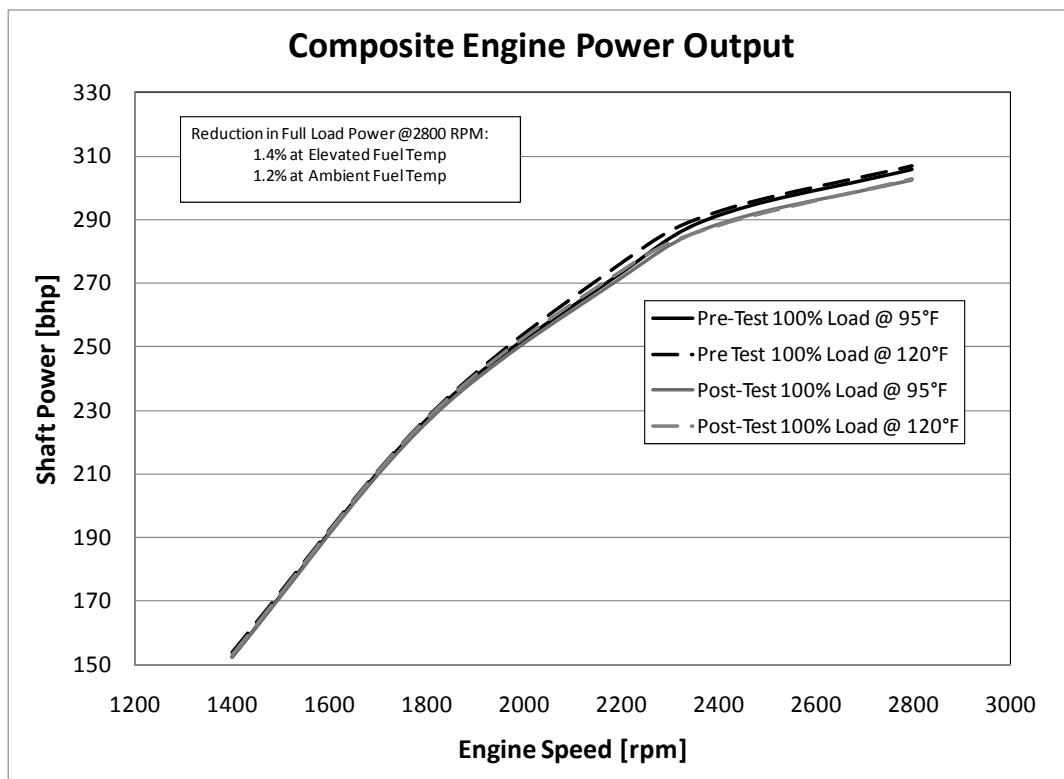
**Figure 11 - Ford 6.7L, SPK, Pre & Post-Test Full Load Powercurve**

Figure 11 below shows the pre and post-test full load powercurve testing for SPK. The engine experienced a respective 1.2% and 1.4% power loss over the test duration at ambient and elevated fuel inlet temperatures.

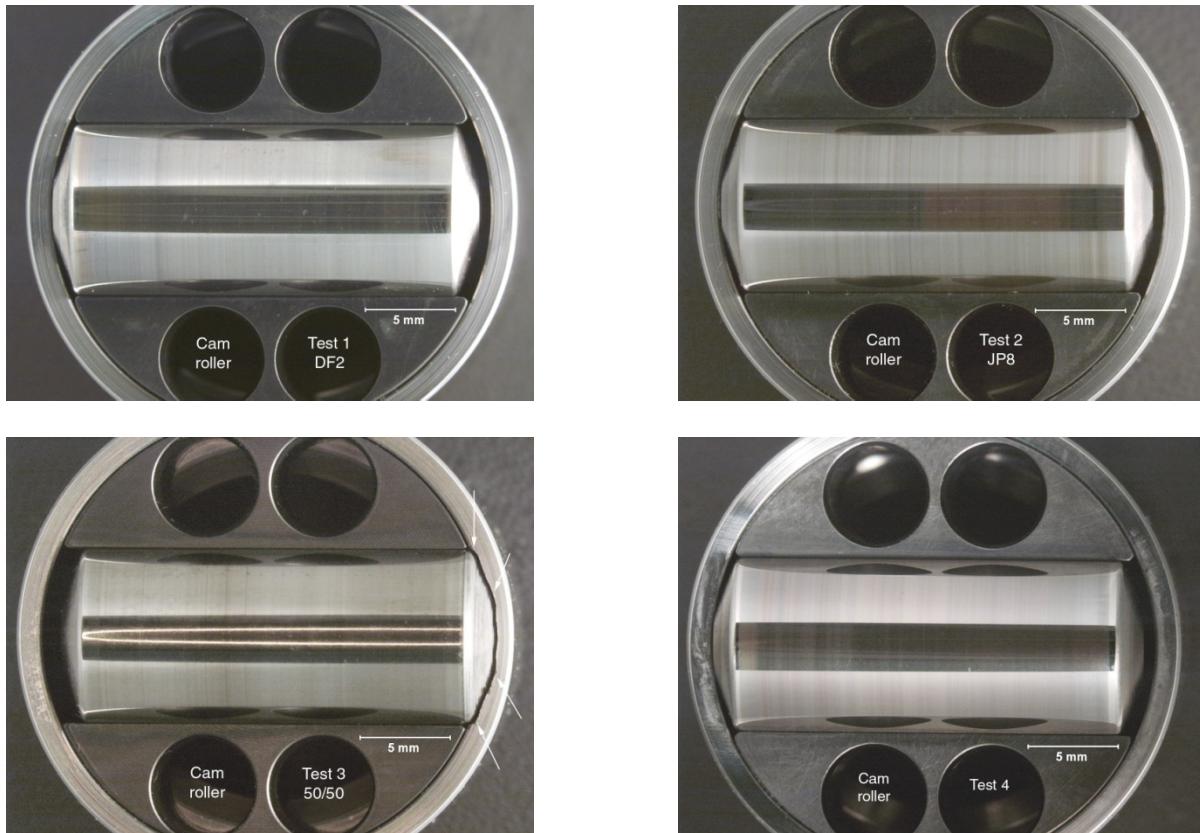
**Figure 28 - Roller Wear Into Follower (1), Left Follower, 50/50 JP-8/SPK**

During inspection of the roller/follower used in the 50/50 JP-8/SPK test, heavy wear at the end of the roller into the body of the follower was observed on the left hand assembly. This wear was not present on the right hand roller, or any other rollers of the remaining tests. It is possible that this could be an isolated problem inherent of a manufacturing flaw within this particular pump. Several different scenarios could potentially cause the roller to preload into the follower wall, such as: slight variation in diameter across the length of the roller resulting in a slight taper on the roller surface, camshaft machining that creates a surface not perpendicular to the roller interface, or bore machining variation resulting in a slightly canted bore. As would be expected, it appears that the extra friction at this location potentially caused higher than normal fuel temperatures in this area lowering the fuel viscosity and contributing to the increased scuffing observed on the left hand follower. Figure 28 and Figure 29 show the roller end wear into the follower assembly.

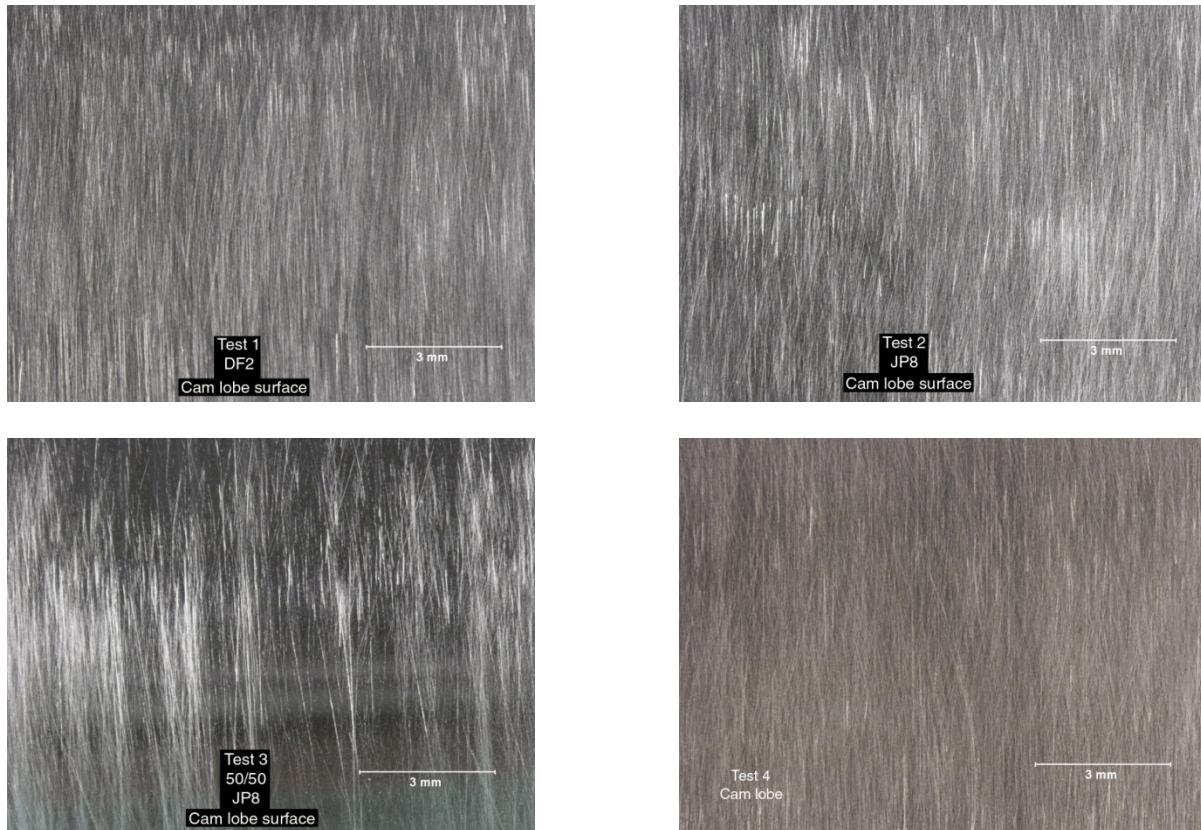
**Figure 31 - Camshaft, ULSD**

Camshaft surfaces showed similar trends as the rollers. Figure 31 shows the camshaft removed from the ULSD tested pump, while Figure 32 shows the camshaft from the 50/50 JP-8/SPK test. Note the slight burnishing (discoloration) of the lobe and journal bearing surfaces. Camshafts were dimensionally measured across the peak of the camshaft lobe for each test to determine if any wear patterns could be determined. The measurements of the post-test camshafts showed no greater variation in surface condition than that of the new unused pump.

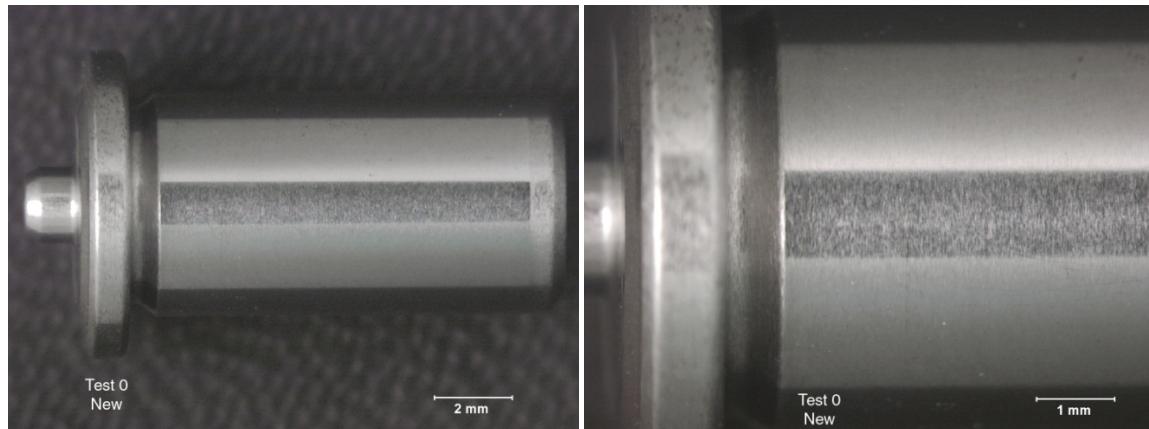
**Figure 38 - Upper Piston, Injector Hydraulic Coupling, Unused**

Consistent with the high pressure fuel pump inspection, fuel injectors from each test were removed and disassembled for inspection and photographs. Due to the size of the fuel injectors internal components, many photos were taken under magnification to better determine any wear patterns present. Inspections were made to the hydraulic coupler pistons, control valve, control plates, injector needle, and nozzle. With the exception of slight deposition differences between the diesel and military fuels (primarily noticed in coloring), no other differing patterns could be identified between the ULSD test and the JP-8 and SPK tests. From the inspection, the only internal injector components showing any appreciable wear patterns were the upper pistons of the hydraulic coupling. As previously explained, the hydraulic coupler is used to translate the small linear movement of the piezo-stack to a larger linear movement to operate the injector control valve and regulate needle lift. From the inspection, it appeared that the piezo-stack imparted a slight side load on the upper piston causing a reacting wear scar to be formed on the outer piston surface. This wear scar was seen in each of the test fuels, and was found to be overall similar in size and condition between the ULSD and military fuels. Figure 38 below shows the condition of the new/unused injector upper hydraulic coupler piston.

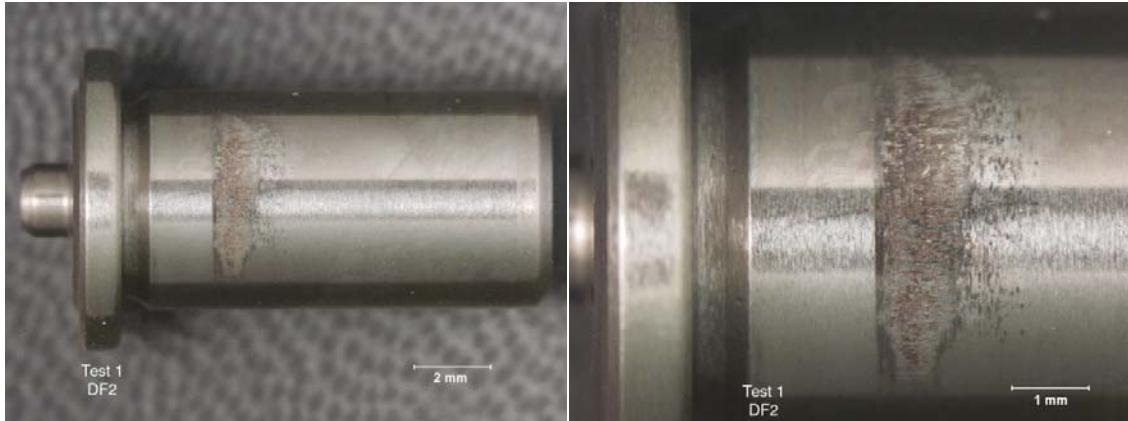
Figure 39 shows the condition of the upper piston removed from the post-test ULSD fuel injector. The slight coloration of the wear scar appears to be oxidation formation on the metal surface where the original surface coating has been completely removed.

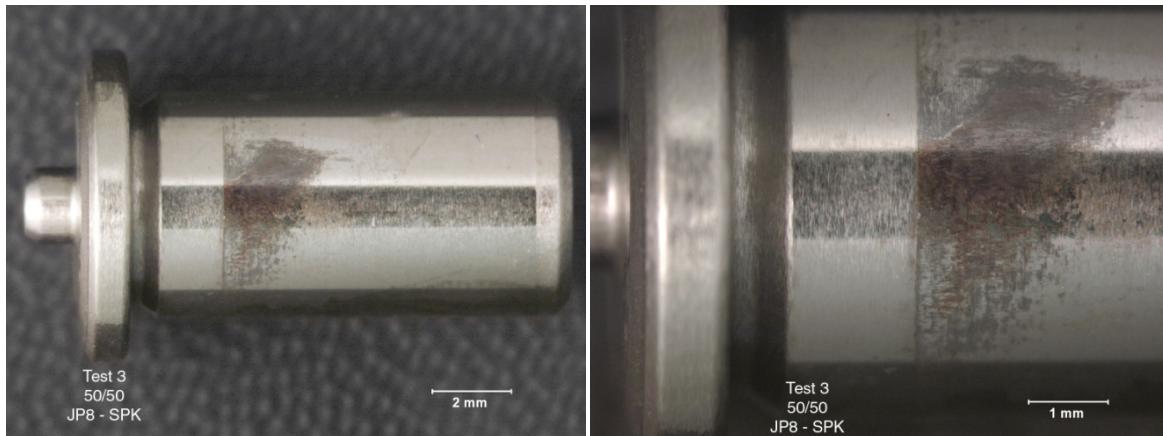
**Figure 41 - Upper Piston, Injector Hydraulic Coupling, 50/50 JP-8/SPK**

Figure 40, Figure 41, and Figure 42 below show the condition of the upper piston removed from the post-test JP-8, 50/50 JP-8/SPK, and SPK fuel injectors respectively. Note the overall similar wear pattern as seen in the ULSD component. Again, the slight coloration of the wear scar appears to be oxidation formation on the metal surface where the original surface coating has been completely removed.

Although this wear did not impact the testing at hand, this type of wear is typical of wear that can be detrimental to fuel injector function if continued. Binding or sticking of the hydraulic coupler will impair the action of the control valve which can potentially result in no fuel being injected into the engine, or a constant flow of injected fuel. Either of these occurring during engine operation would require immediate fuel injector replacement to ensure proper engine operation.

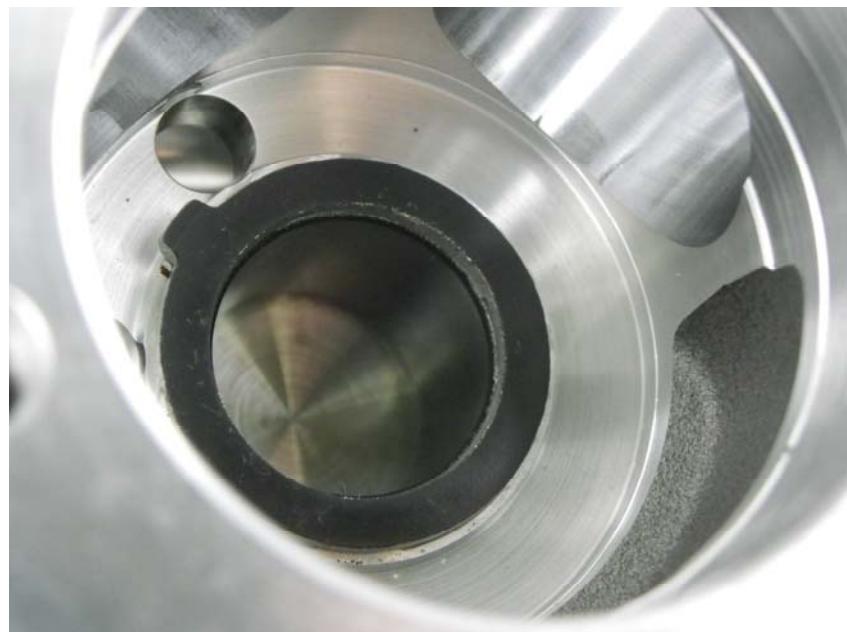
**Figure 8 - AF7469 ULSD, Post Test, Right Pump Bore**

Figure 8 shows the right hand pump body bore, while Figure 9 shows a close up picture of the light polish found on the bore surface similar to the left hand bore.

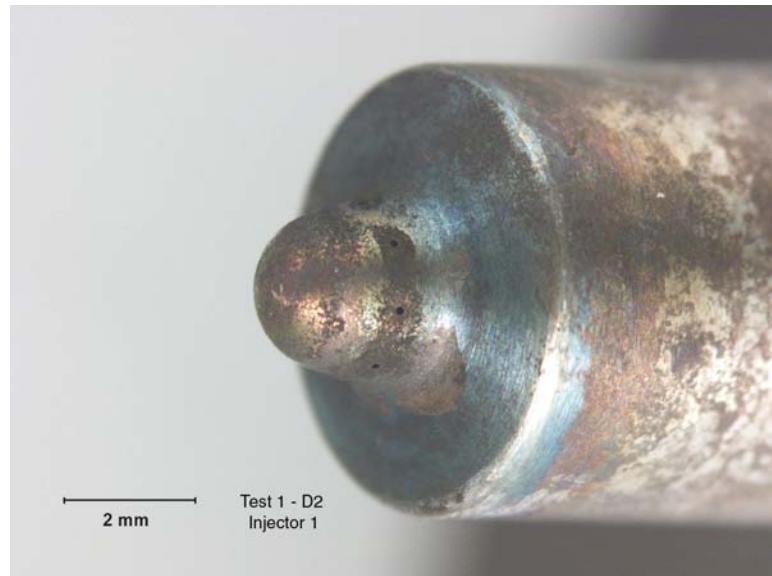
**Figure 22 - AF7469 ULSD, Injector Nozzle**

The following photos document the post test fuel injector hardware condition. Figure 22 shows the injector nozzle tip. No substantial deposit formations were seen under low magnification. Figure 23 below shows the injector needle tip. No abnormal wear or markings were found on the tapered seat.

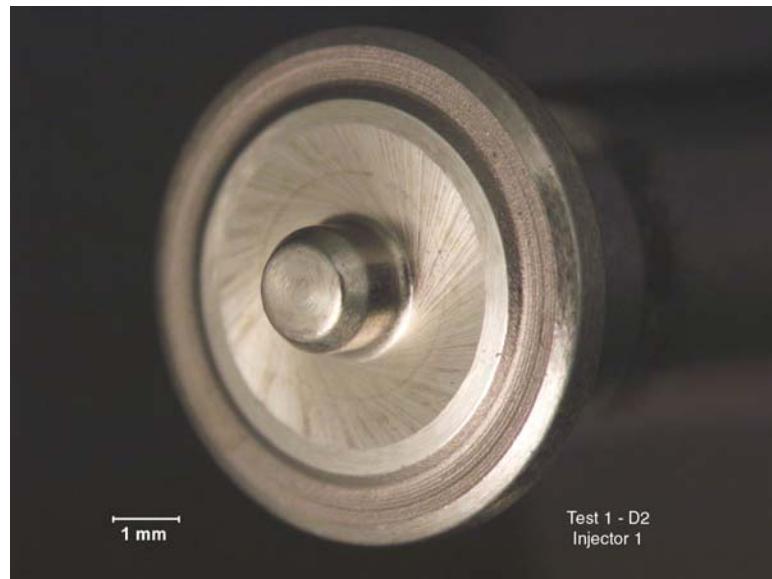
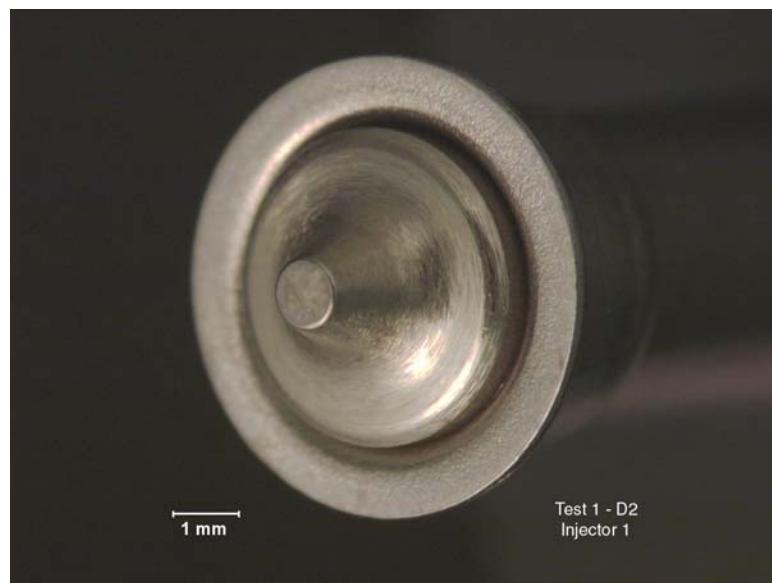
Figure 24 and Figure 25 shows the upper and lower hydraulic coupler pistons respectively. No noticeable wear was seen on the piston surface interface, or at the heads of the piston at the piezo- stack and control valve interface.

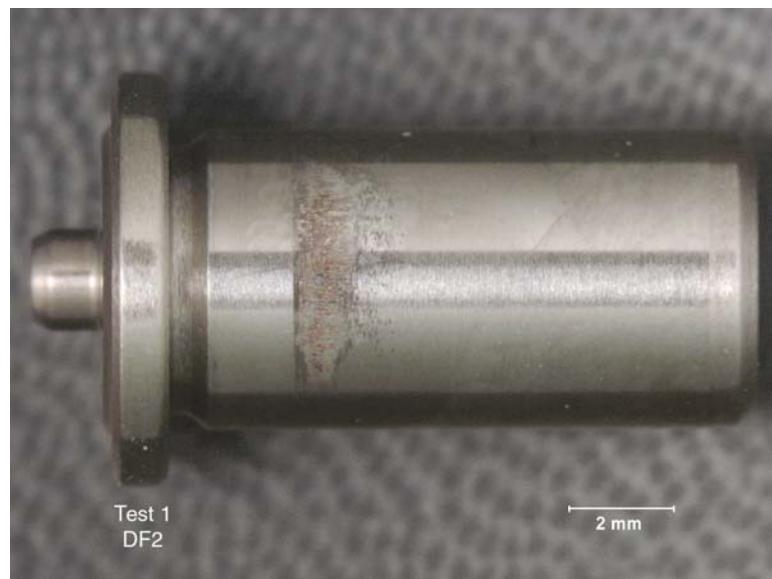
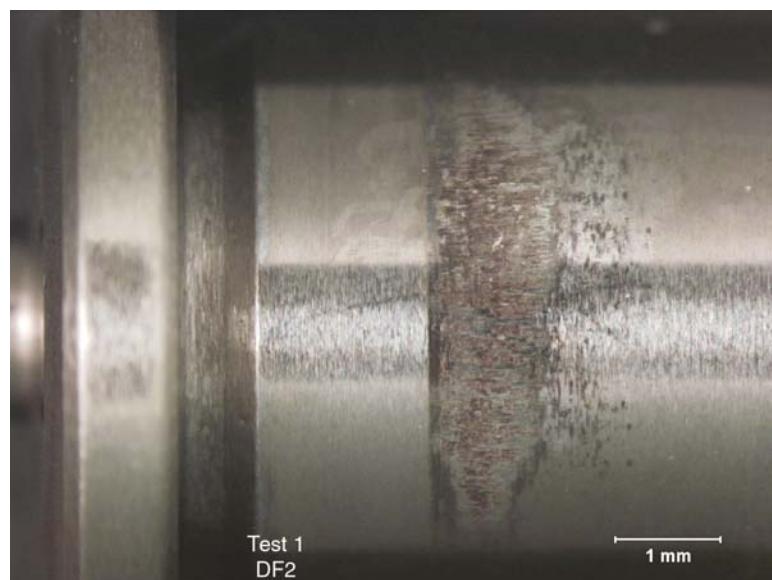
Figure 24 and Figure 25 shows the side profile of the upper hydraulic coupler piston. A wear scar shows on the surface of the piston consistent with wear expected from being slightly cocked in the bore when depressed by the piezo-stack.

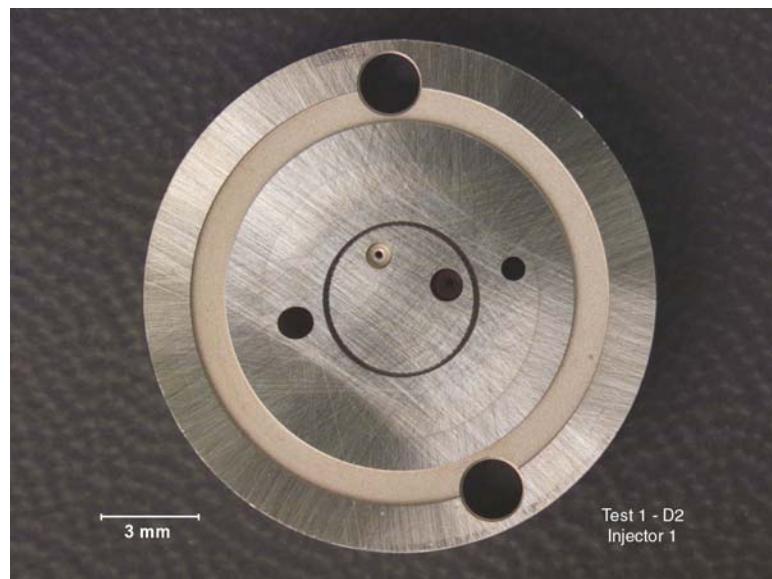
**Figure 28 - AF7469 ULSD, Intermediate Plate (Top)**

Figure 28 and Figure 29 shows the top and bottom surfaces of the intermediate plate. This plate contains the fuel control passages used to manipulate the needle position.

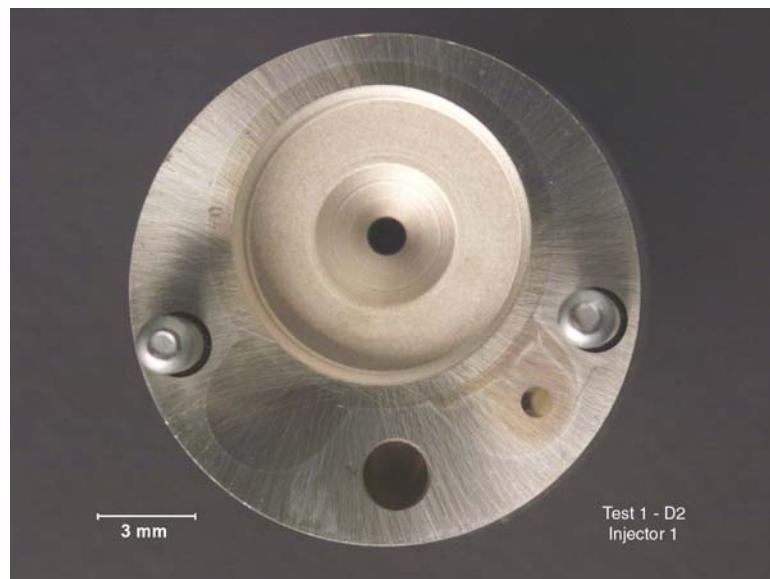
**Figure 30 - AF7469 ULSD, Control Valve Plate (Top)**

Figure 30 and Figure 31 shows the top and bottom of the control valve plate. The control valve sits in the bore shown in Figure 31. The lower piston of the hydraulic coupler operates in the bore shown in Figure 30.

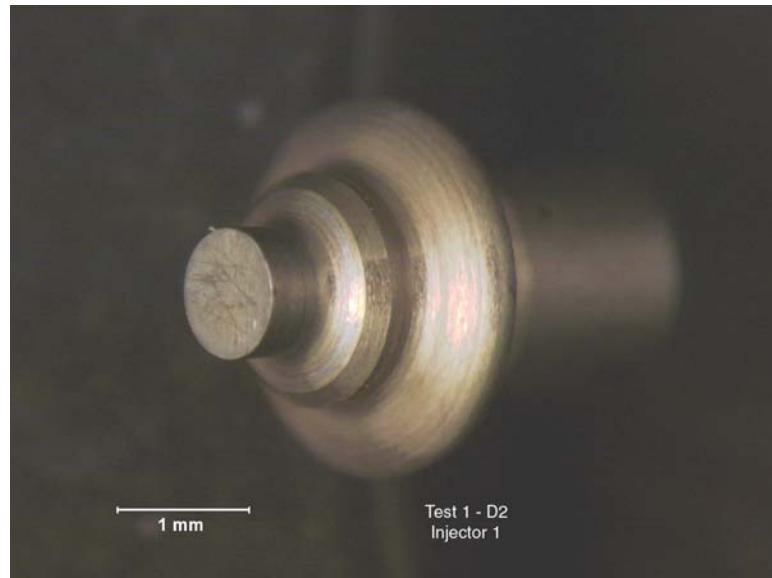
**Figure 32 - AF7469 ULSD, Fuel Injector Control Valve**

Figure 32 shows the control valve which regulates the pressure on top of the injector needle, thus controlling lift. No unusual wear was found on the control valve.

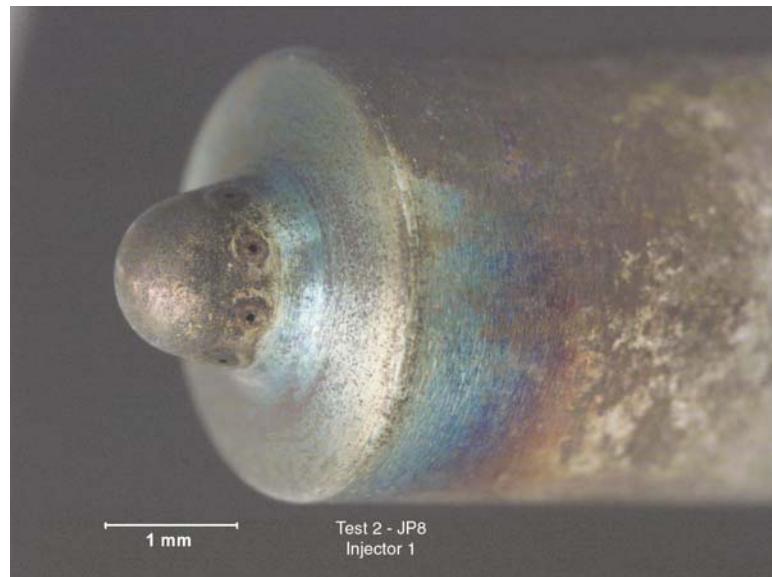
Figure 25 - AF7801 JP8, Injector Nozzle

The following photos document the post test fuel injector hardware condition. Figure 25 shows the injector nozzle tip. No substantial deposit formations were seen under low magnification. Figure 26 below shows the injector needle tip. No abnormal wear or markings were found on the tapered tip.

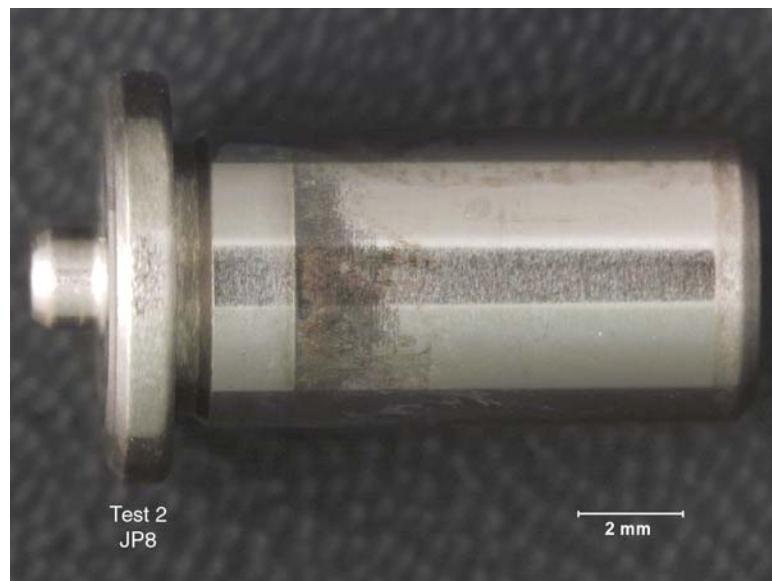
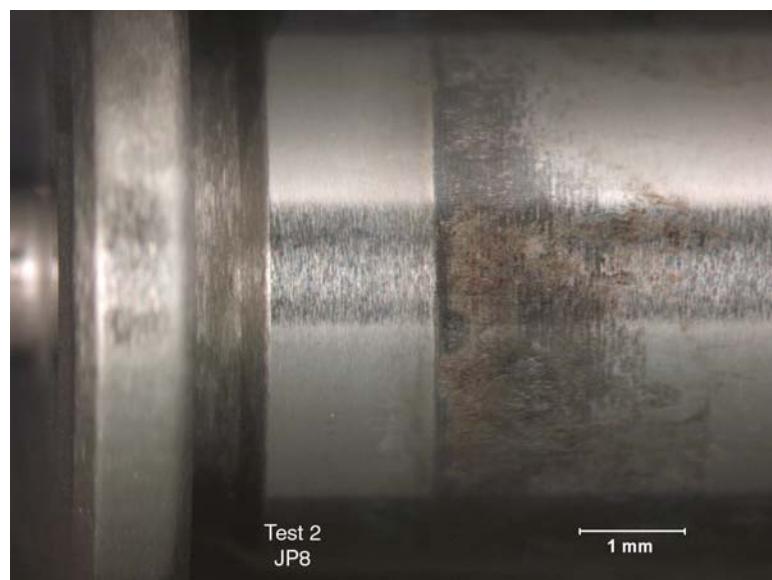
Figure 27 and Figure 28 shows the upper and lower hydraulic coupler pistons respectively. No noticeable wear was seen on the piston surface interface, or at the heads of the piston at the piezo stack and control valve interface.

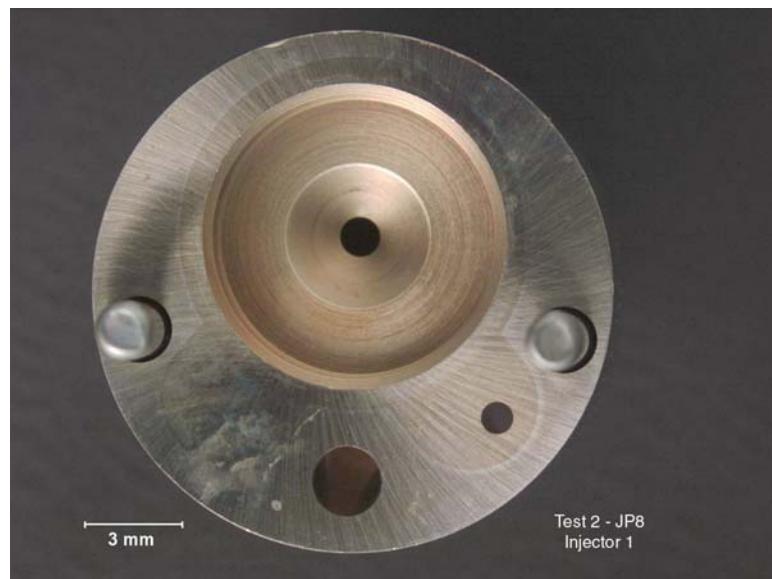
**Figure 31 - AF7801 JP8, Intermediate Plate (Top)**

Figure 31 and Figure 32 shows the top and bottom surfaces of the intermediate plate. This plate contains the fuel control passages used to manipulate the needle position.

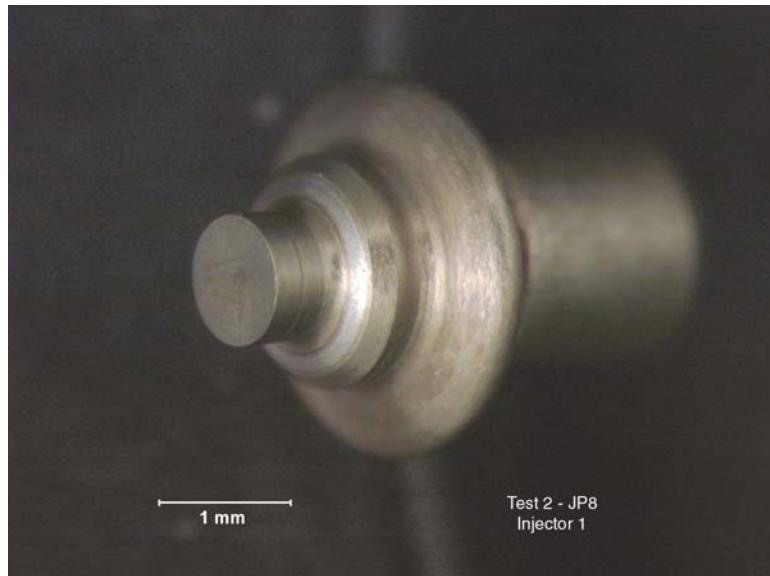
**Figure 33 - AF7801 JP8, Control Valve Plate (Top)**

Figure 33 and Figure 34 shows the top and bottom of the control valve plate. The control valve sits in the bore shown in Figure 34. The lower piston of the hydraulic coupler operates in the bore shown in Figure 33.

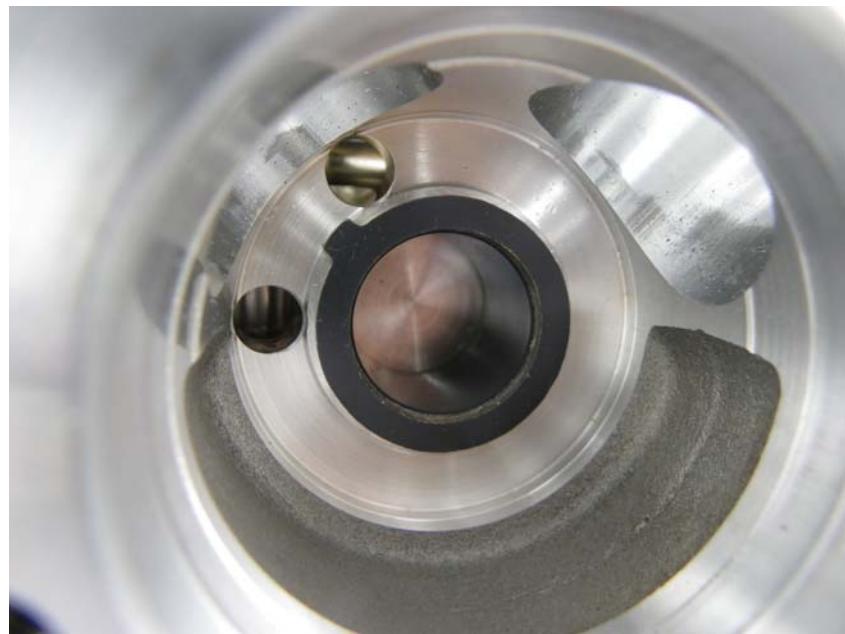
**Figure 11 - AF7824 50/50 JP8/SPK, Post Test, Right Pump Bore**

Figure 11 shows the right hand pump body bore. Figure 12 shows a close up picture of the light polish and scuffing found on the bore surface similar to the left hand bore.

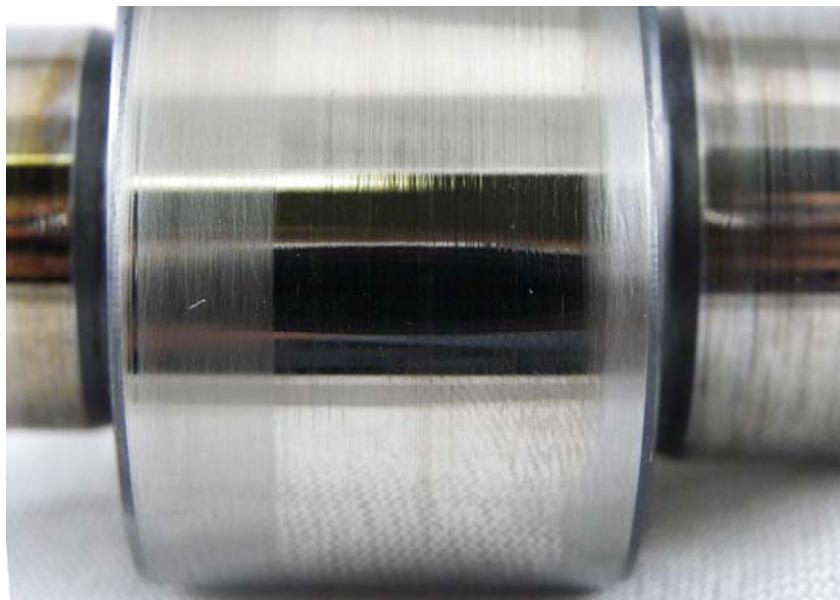
**Figure 16 - AF7824 50/50 JP8/SPK, HPCR Pump Camshaft,  
Lobe Surface Close-up**

Figure 16 shows a close-up of a cam lobe peak. A polish and light burnish can be seen in the contact areas of the cam surface, but no measureable wear is detected. A light burnish was also noted on the journal bearing surface of the cam.

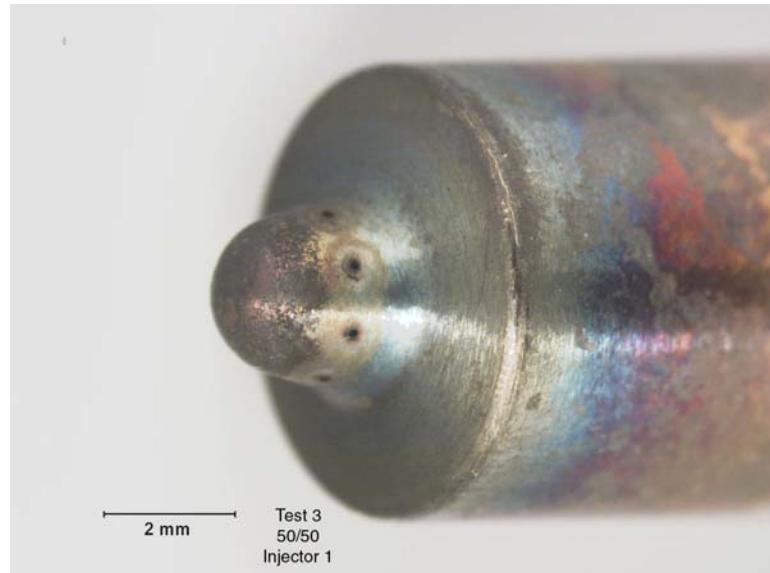
Figure 28 - AF7824 50/50 JP8/SPK, Injector Nozzle

The following photos document the post test fuel injector hardware condition. Figure 28 shows the injector nozzle tip. No substantial deposit formations were seen under low magnification. Figure 29 below shows the injector needle tip. No abnormal wear or markings were found on the tapered tip.

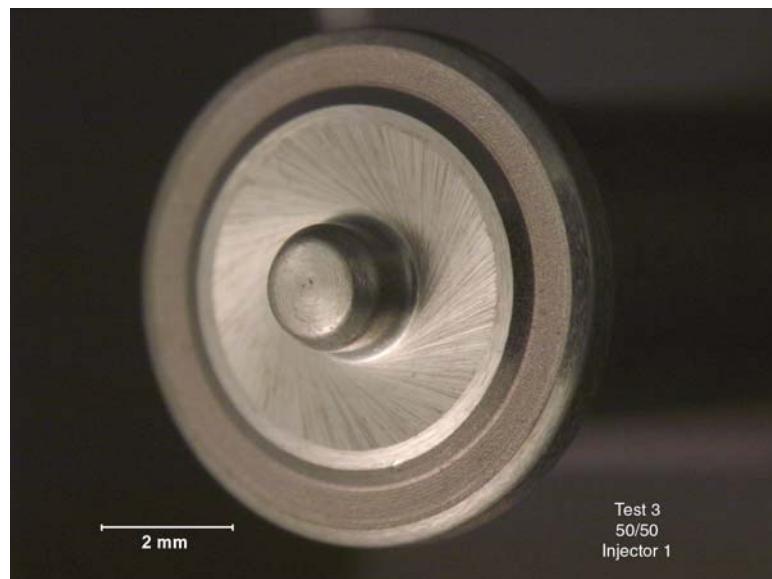
Figure 30 - AF7824 50/50 JP8/SPK, Upper Hydraulic Coupler Piston

Figure 30 and Figure 31 shows the upper and lower hydraulic coupler pistons respectively. No noticeable wear was seen on the piston surface interface, or at the heads of the piston at the piezo stack and control valve interface.

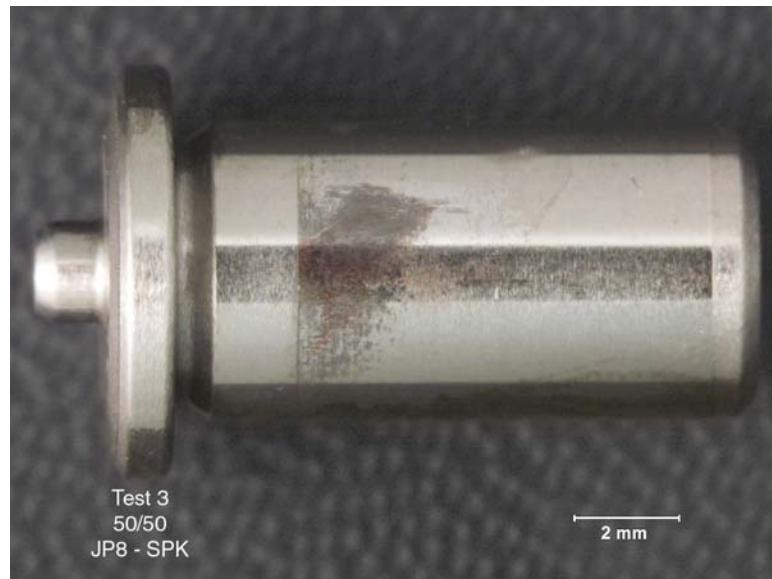
**Figure 32 - AF7824 50/50 JP8/SPK, Upper Hydraulic Coupler Piston, Profile**

Figure 30 and Figure 31 shows the side profile of the upper hydraulic coupler piston. A wear scar shows on the surface of the piston consistent with wear expected from being slightly cocked in the bore when depressed by the piezo-stack.

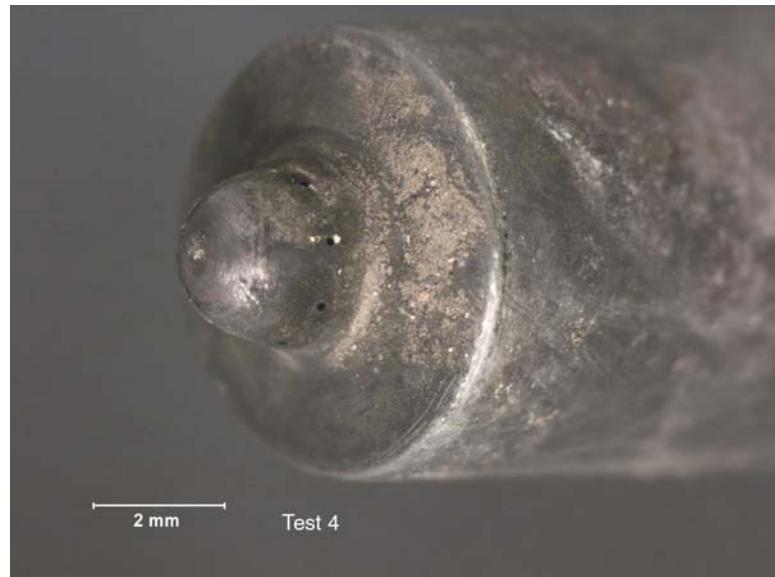
Figure 25 - AF7868 SPK, Injector Nozzle

The following photos document the post test fuel injector hardware condition. Figure 25 shows the injector nozzle tip. No substantial deposit formations were seen under low magnification. Figure 26 below shows the injector needle tip. No abnormal wear or markings were found on the tapered tip.

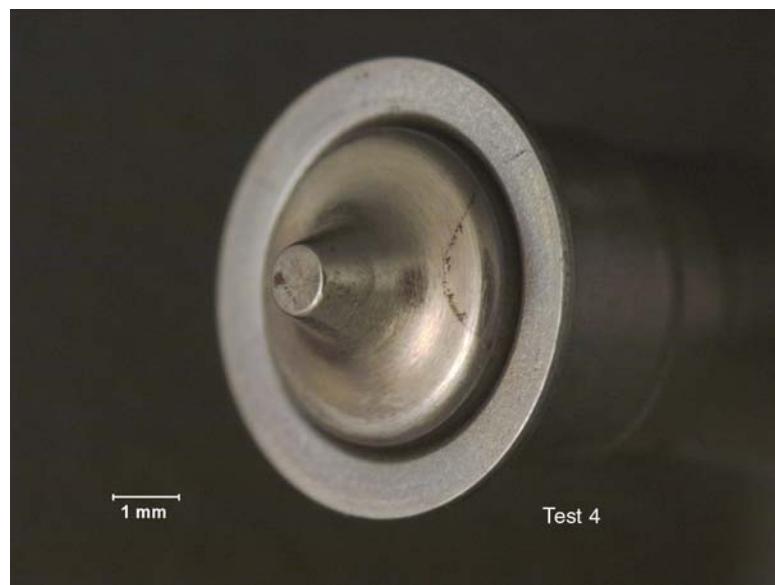
**Figure 27 - AF7868 SPK, Upper Hydraulic Coupler Piston**

Figure 27 and Figure 28 shows the upper and lower hydraulic coupler pistons respectively. No noticeable wear was seen on the piston surface interface, or at the heads of the piston at the piezo stack and control valve interface.

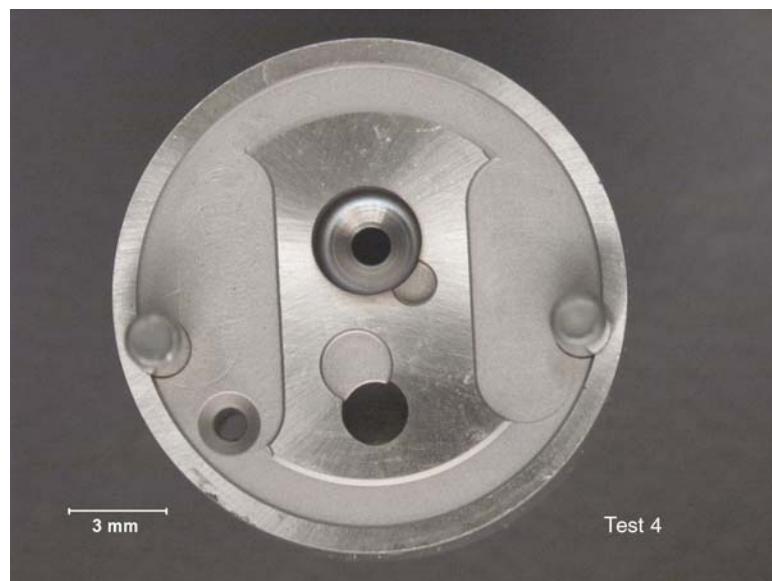
**Figure 32 - AF7868 SPK, Intermediate Plate (Bottom)**

Figure 31 and Figure 32 shows the top and bottom surfaces of the intermediate plate. This plate contains the fuel control passages used to manipulate the needle position.

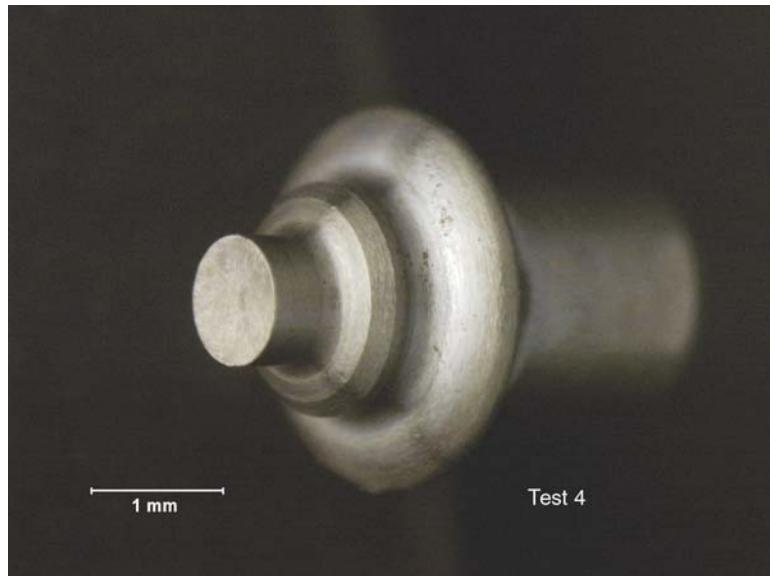
**Figure 33 - AF7868 SPK, Control Valve Plate (Top)**

Figure 33 and Figure 34 shows the top and bottom of the control valve plate. The control valve sits in the bore shown in Figure 34. The lower piston of the hydraulic coupler operates in the bore shown in Figure 33.
